Ultrasonic Control of Algae

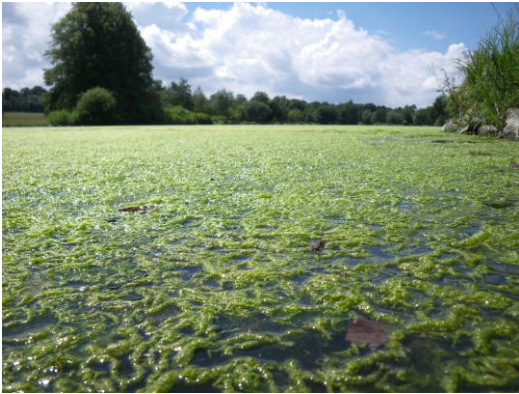
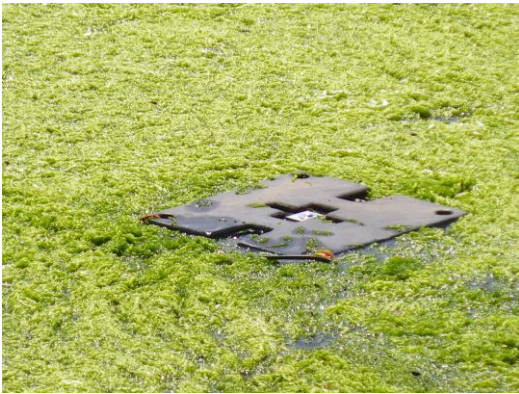
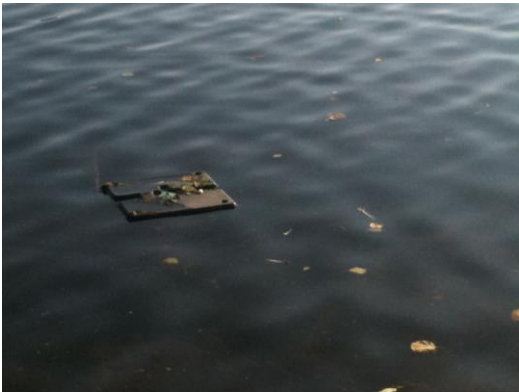
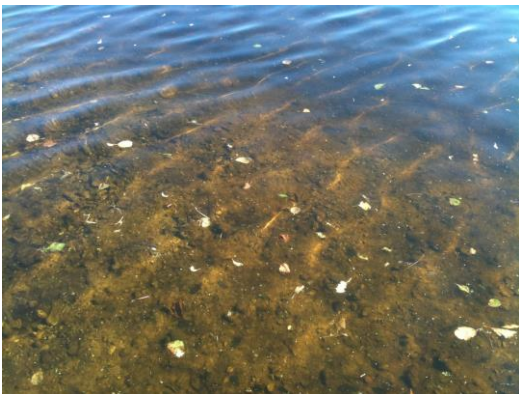
Filamentous algae are relatively difficult to control, and *Enteromorpha* is especially difficult using ultrasound because of the numerous air bubbles within the structure, which tend to absorb ultrasound strongly. However, with about 6 – 8 weeks the existing mat had sunk to the bottom and had started to die off. The bottom became visible and the aesthetics were significantly improved. Access to the lake was possible with boats, the ducks enjoyed improved feeding due to clearer water and grew better

The limit of detection was visible due to shadows behind islands where the ultrasound signal could not reach, but with improved water movement the algae was killed when it came into line of sight of the ultrasound transducer. By leaving the systems on all year for 24 hours a day continued control of algae has been possible. Running costs are very low with 24V DC systems, just the occasional battery every 2 – 3 years. Free energy from the sun and wind means remote deployment is not a problem.

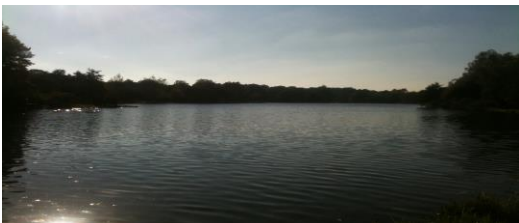
A private estate in Norfolk had problems with floating blanket weed, *Enteromorpha intestinalis*. The algae was preventing access to the lake and causing a serious aesthetic issue with sight lines. Nutrients in the lake are continually replenished from a diversionary flow from the adjacent river, so algal growth was unchecked. The lake is relatively shallow with a maximum depth of no more than 3m. The total area is about 12 hectares, less a few islands. We installed two solar powered 24V DC EV-300 units, one at either end of the lake pointing towards the middle.
